American Champion Aircraft Corp.  
Rochester, WI 53167

Service Letter: 424

Title: Inspection of Flap Wing Root Pulley and Cable

Models: Bellanca/American Champion, 7GCB, 7GCBC, 8GCBC, All Serial Numbers

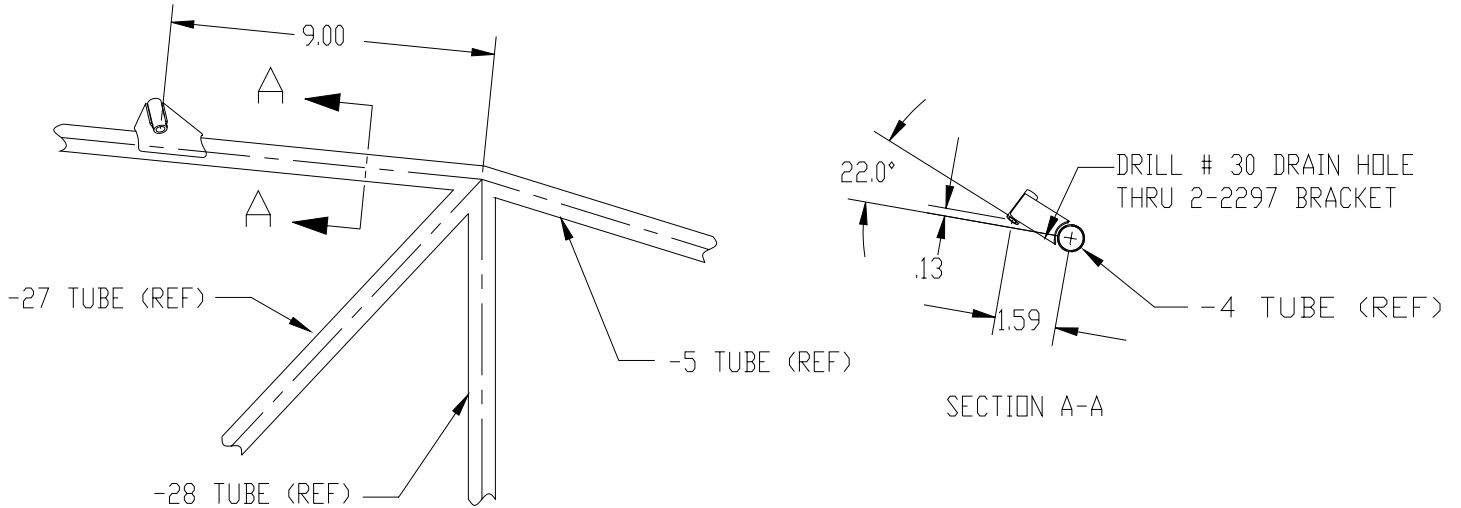
**Figure 1, 2-2297 Bracket Installation**

Description: Flap pulley wear and cable fraying have been reported. The wing root flap pulleys and cables should be inspected for wear and lubrication using the Inspection Intervals and the Procedure in the next two sections of this letter. Proper pulley and cable lubrication will reduce wear.

Installation of an optional bracket and larger flap pulley will further reduce wear and allow for inspection at standard service intervals (see Inspection Intervals, Optional Retrofit, and Parts Required sections below).

- 1) Remove fabric, 4" diameter hole centered on flap bracket
- 2) Remove 2-1597 bracket, cut and grind flush to fuselage frame
- 3) Install 2-2297 bracket per figure 2, weld all exterior edges per champion specification CW-1 or other industry accepted process for tubular steel welding
