Service Letter: 452

Date: March 19, 2020

Title: Relocation of Cowl Fastener

Models: 8KCAB (AEIO-390-A1B6 engine, serial numbers 1179-2018 and prior);  
8GCBC (IO-390-A1B6 engine, serial numbers 596-2019 and prior);  
When seven screws secure lower cowl to noseowl

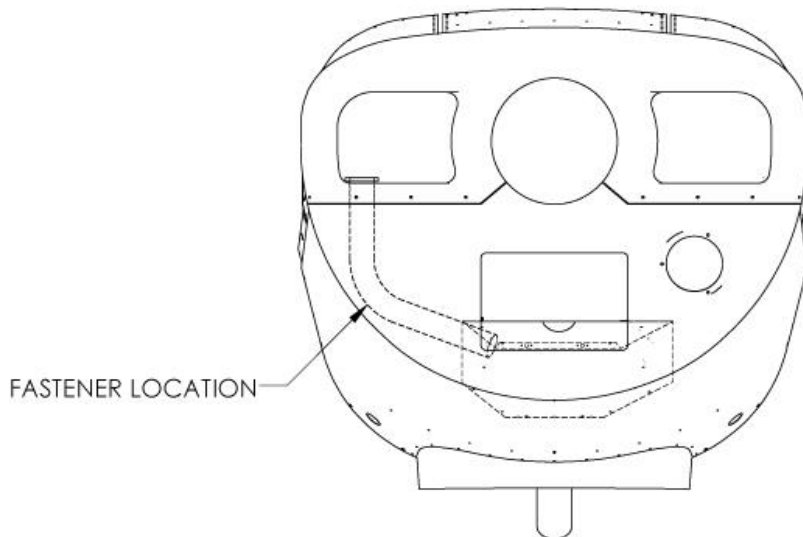
**Figure 1, Fastener Location**

Description: Wear of the #1 cylinder exhaust tube by a cowl fastener has been reported on several aircraft. This service letter provides for inspection of the exhaust tube, replacement of the tube (if damaged), and relocation of the cowl fastener (if exhaust tube is worn). If modification of the lower cowl is not desirable it may be replaced with a later revision part having nine evenly spaced holes.

1. Open left side cowl door (4 camlocks).
2. Observe clearance between cowl fastener and #1 exhaust tube at location shown in Figure 1 (typical clearance is .25 inch with AN526C1032R6 screw). Visually inspect #1 exhaust tube for indications of damage (wear/chafing from screw or nutplate). It may be necessary to use a mirror to view the front of the exhaust tube with the cowling installed.

3. If damage to exhaust is noted replace 3-1791 exhaust tube with serviceable part per AMM. Modify to the cowl fastener location to prevent abrasion. If wear is not noted and clearance is adequate; inspect at next 100-hour or annual inspection.
4. Close left side cowl door (4 camlocks).
