Service Letter: 457

Title: Lycoming Electronic Ignition System Placard

Models: 8GCBC (S/N's 611-2021, 614-2021, 615-2021, 616-2021, 617-2021, 618-2021)

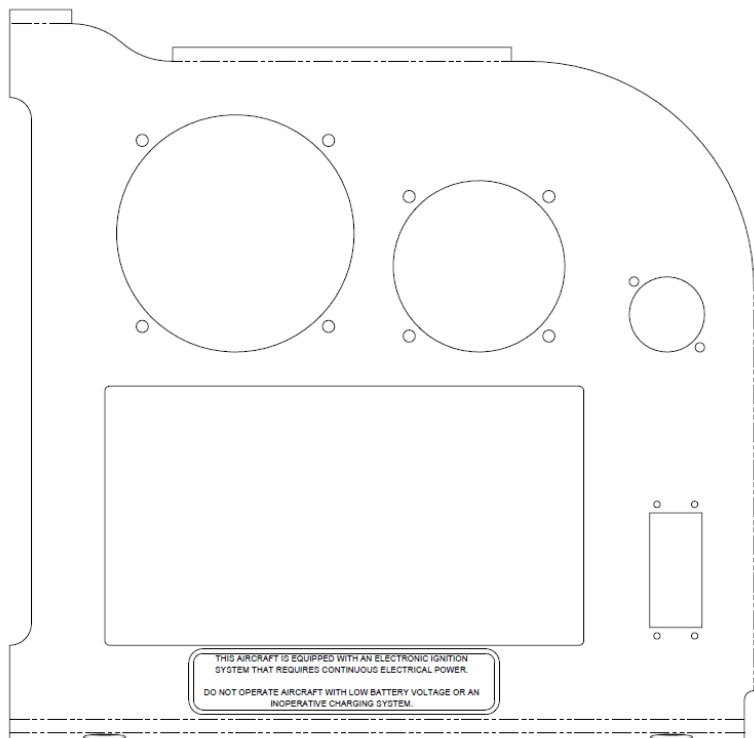
**Figure 2: 11-1264 Placard Placement**

Description: There was an error made in production where the required placard for the Lycoming EIS system may not have been installed on the instrument panel in a few select aircraft. This service letter outlines the procedures necessary to apply the required placard to the instrument panel on those aircraft equipped with the Lycoming EIS system.

2. If the placard is missing, apply placard to instrument panel. Clean instrument panel prior to application. Placard is to be centered below the radio stack. Placement can be seen in Figure 2.
