Service Letter: 434

Title: Door Release Pin and Ring

Effectivity: 7ECA, 7GCAA, 7GCBC, 7KCAB, 8KCAB, and 8GCBC models manufactured before July 1, 2011 as indicated by the aircraft data plate. Aircraft manufactured after July 1, 2011 comply with this service letter.

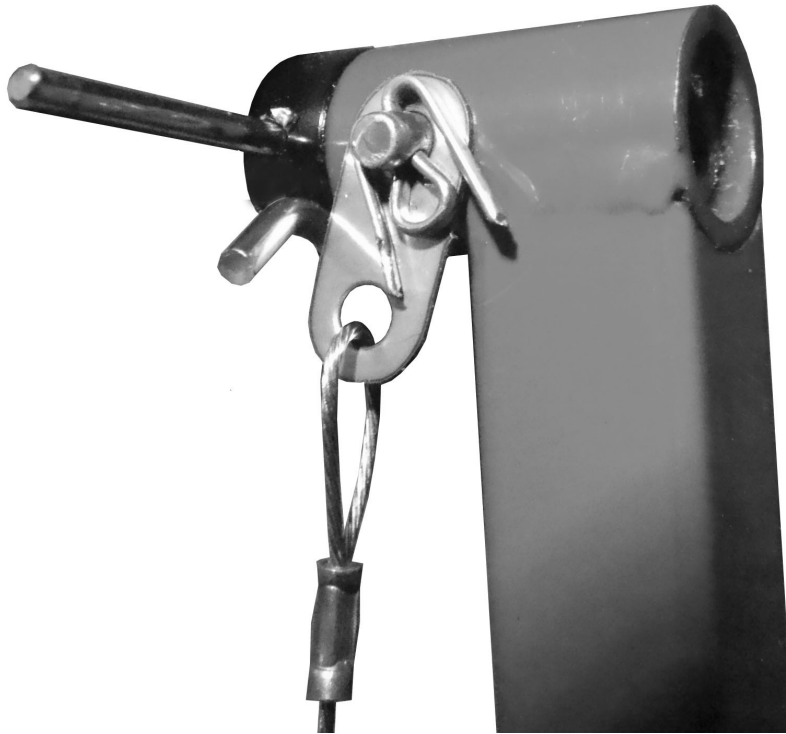
**Figure 1, Installation Lanyard Tab**

Description: Inadvertent removal of the door release pin and ring from the emergency door release handle is possible especially when entering or exiting the front seat of the airplane. There are two known service difficulty reports where the emergency door release pin and ring have become dislodged and partially jammed a flight control. This service letter provides a means to tether the pin and ring to the emergency door release handle.

1. Remove and discard current door release pin and ring.
2. Remove cotter pin securing MS20392-1C17 clevis pin. Clevis pin may be reused or replaced as necessary.
3. Install tab of 2-2352 lanyard assembly on MS20392-1C17 clevis pin. Secure with AN380-2-2 cotter pin as shown in figure 1.
4. Install door release pin through fuselage bushing and handle assembly as shown in figure 2.
