Service Letter: 455

Title: Air box Screw/Bolt Abrasion

Models: All American Champion / Bellanca 8KCAB, 8GCBC, 7KCAB, 7GCBC, 7GCAA, and 7ECA aircraft manufactured prior to 07-15-2022. Excluding any models that have been modified with either, 3-1776 revision C (Assembly - Airbox) or later approved revision, or 4-1637 revision Q (Assembly Carb. Air Box) or later approved revision.

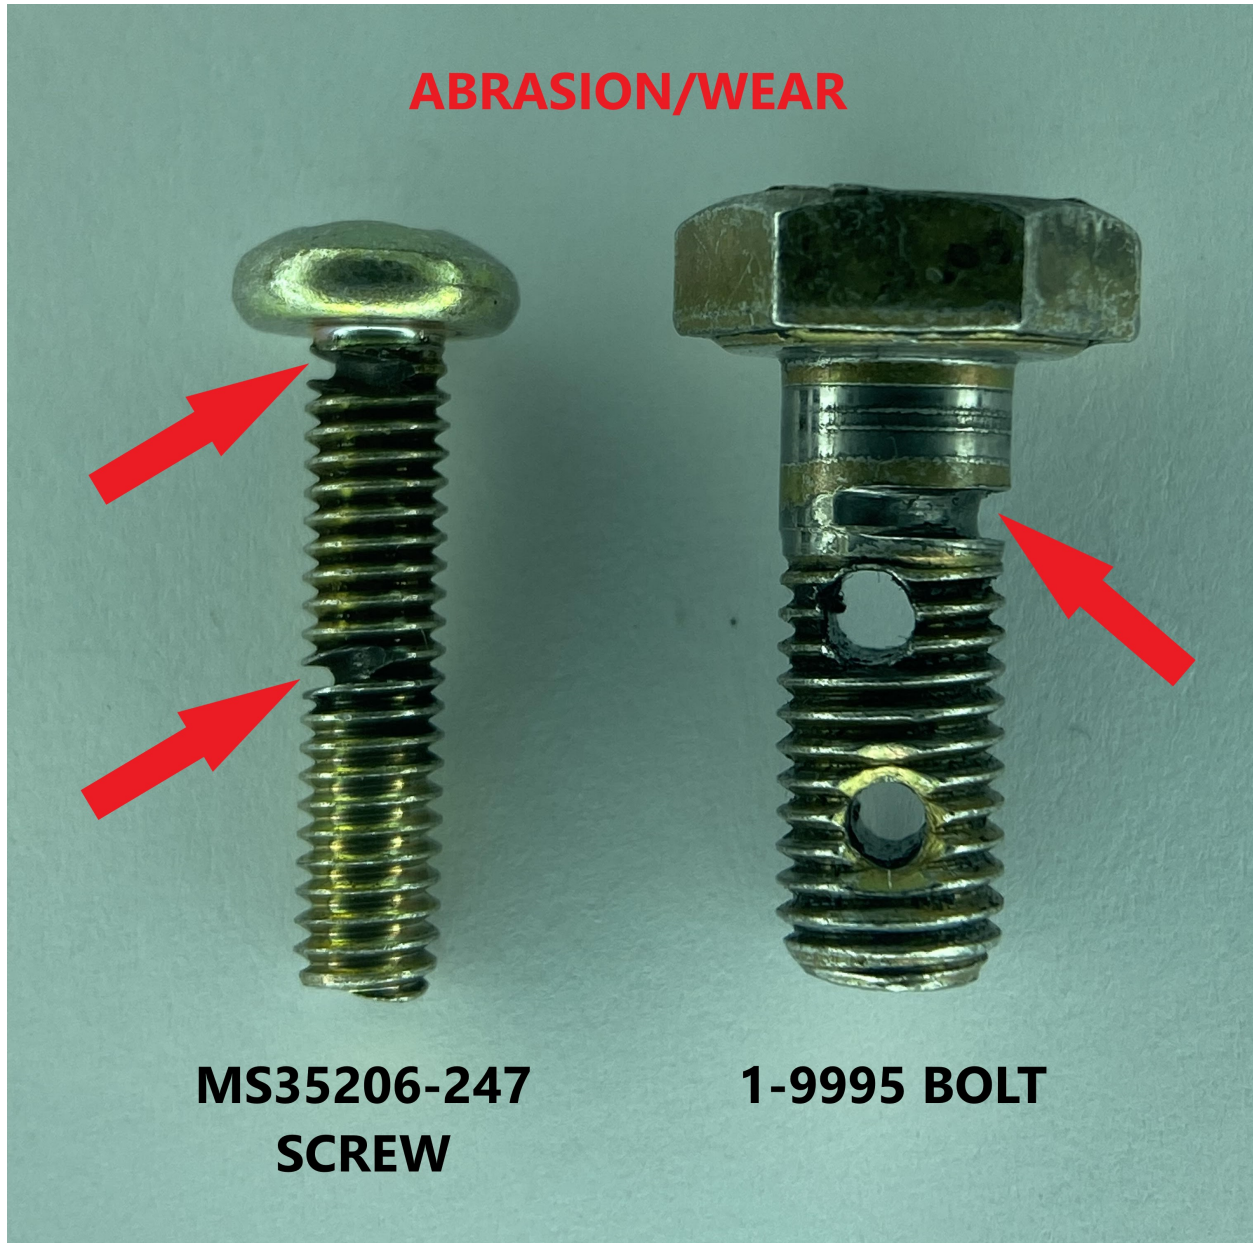
5. Remove air box. In order to remove the air box the control cable must be disconnected from the valve shaft arm. To disconnect the control cable remove bolt 1-9995. Inspect bolt 1-9995 for abrasion or wear. Working on the air box, remove the two MS35206-247 screws holding the shaft to the valve. Inspect screws for abrasion or wear. Examples of abrasion are shown in Figure 1.

Figure 1: Example of Abrasion/Wear of Air Box Hardware

6. If abrasion is noted, replace the air box per the following sections depending on the air box equipped to your aircraft.
7. If abrasion or wear is not present, inspect at next 100-hour or annual inspection.
